Technical Report ARAED-TR-96002

**METALLURGICAL ANALYSIS OF AN ALUMINUM SABOT FIRED
IN THE CANNON CALIBER ELECTROMAGNETIC GUN (CCEMG)**

Stacey Clark Kerwien

June 1996

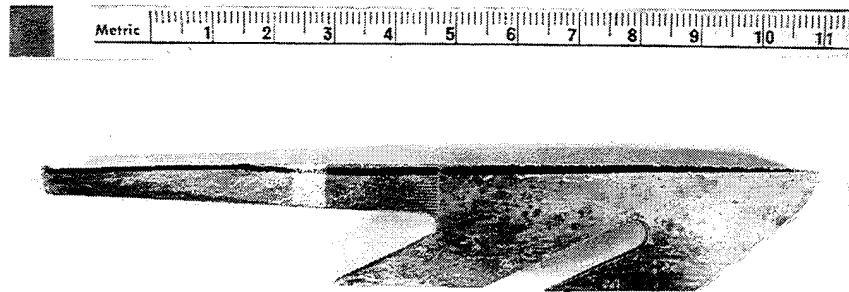
One of the two sabots fired during shot 11 was found at the ARL test range (fig. 1). The contact surfaces of the sabot were examined macroscopically with the SEM at low magnification to qualitatively determine the extent of melting. One of the sabot halves was mounted in epoxy and polished to perform hardness measurements [diamond pyramid hardness (DPH)], semi-quantitative chemistry using energy dispersive x-rays (EDAX), and conductivity measurements. Then, the specimen was etched to reveal the microstructure.

The rear contact surfaces of the sabot melted more and lost more material than the front contacts. This suggests that the rear contacts carried more current and/or had more intimate mechanical contact with the rails. The tips of all of the contact surfaces had melted off and were somewhat deformed.

A significant amount of melting was also seen in the tail region (or projectile stabilizer). Since the tail does not contact the rails, melting must be due to the extremely high temperature of the launcher atmosphere. The temperature of the launcher is high as a result of the high electrical currents and the pyrophoric nature of aluminum particles.

Figure 1
Sectioned sabot

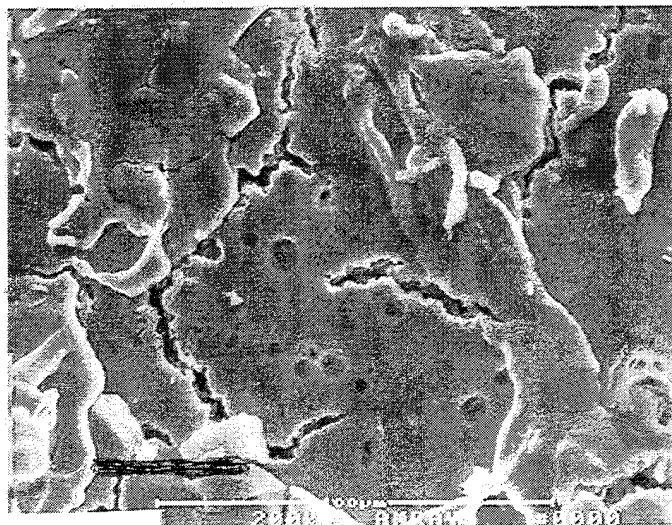
Figure 2 shows an SEM photograph of the rear contact surface near the tip. Bubbles and cracks in the structure are a result of high temperature oxidation (HTO). This occurs when aluminum is heated to its solution temperature or beyond in an atmosphere that contains water. Atomic hydrogen from the water reacts with the aluminum surface and diffuses through the aluminum lattice. The hydrogen then recombines to form molecular hydrogen, which is what causes the bubbles to form.

1. The presence of water in the launcher caused high temperature oxidation on the contact surfaces of the sabot. High temperature oxidation caused the bubbles and cracks seen on the contact surfaces.

Figure 2
SEM of rear contact surface (540X)

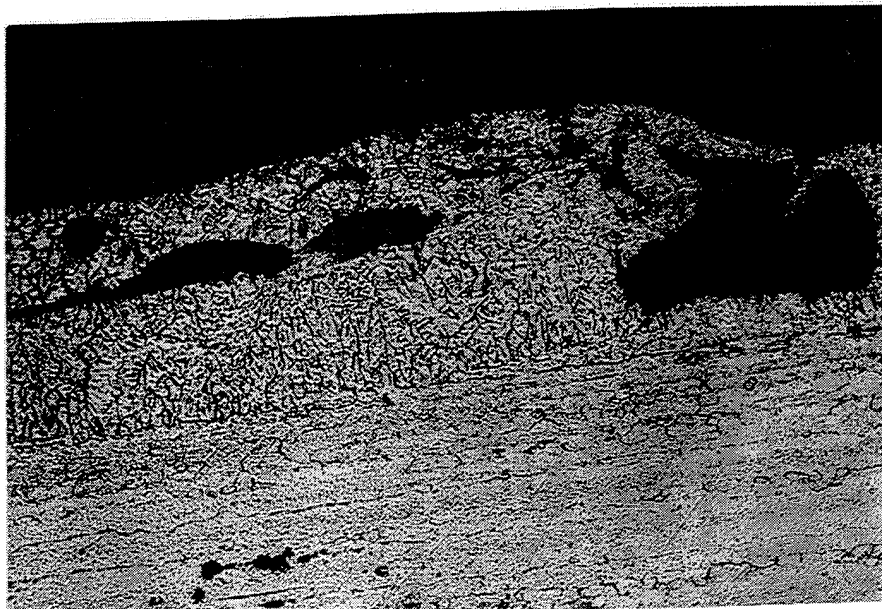
Examination of the sabot microstructure focused on the rear contact surface since it had the highest degree of melting. Figure 4 shows an area of high temperature oxidation in the rear contact surface. Here the aluminum has bubbled, deformed, and resolidified--forming a different microstructure than is typical for Al-7475. In fact, the microstructure in figure 4 is similar to an electron beam welded Al-7475. A network of interdendritic aluminum, magnesium, and silicon compounds has replaced the elongated grains of aluminum.

2. Extremely high temperatures caused the contact surfaces of the sabot to develop a microstructure similar to an electron beam welded structure.
3. Cracking at the roots and tips of the contact surfaces is caused by overheating and, subsequently, over-aging of the aluminum sabot. This results when certain elements, such as magnesium and silicon, diffuse out of the Al-7475 alloy and precipitate along the grain boundaries of the aluminum. Cracks initiate along the grain boundaries because they have been substantially weakened. Cracking in the root area is not caused by mechanical stresses and is not related to the fracture toughness of the material.

Figure 4
Microstructure of rear contact surface (500X)

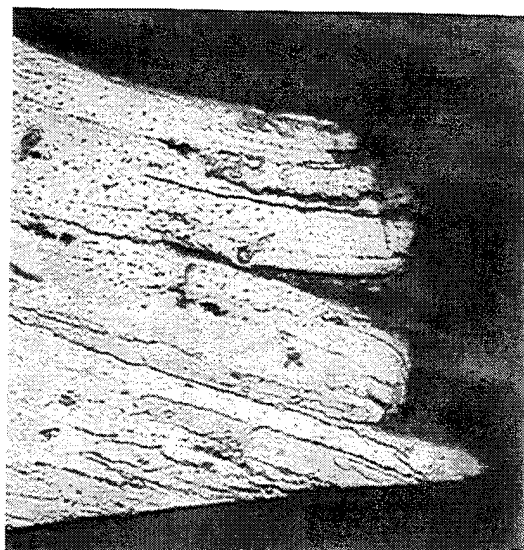
Figure 5 shows the very tip of the rear contact. The temperature was so concentrated that the elongated grains of aluminum have separated along the grain boundaries. This effect is called over-aging.

Figure 5
Microstructure of tip of rear contact surface (75X)

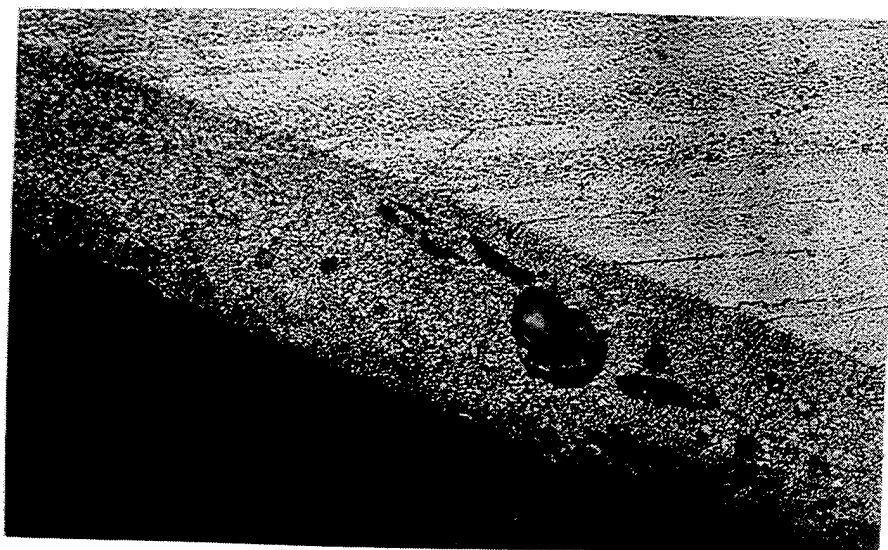
Figure 6 is the microstructure of the area on the bottom side of the rear contact surface. Even though this side did not come in contact with the rails, it also melted, formed bubbles, and developed a microstructure similar to that in figure 4. The bubbles are caused by high temperature oxidation.

Figure 6
Microstructure of bottom-side of rear contact surface (500X)

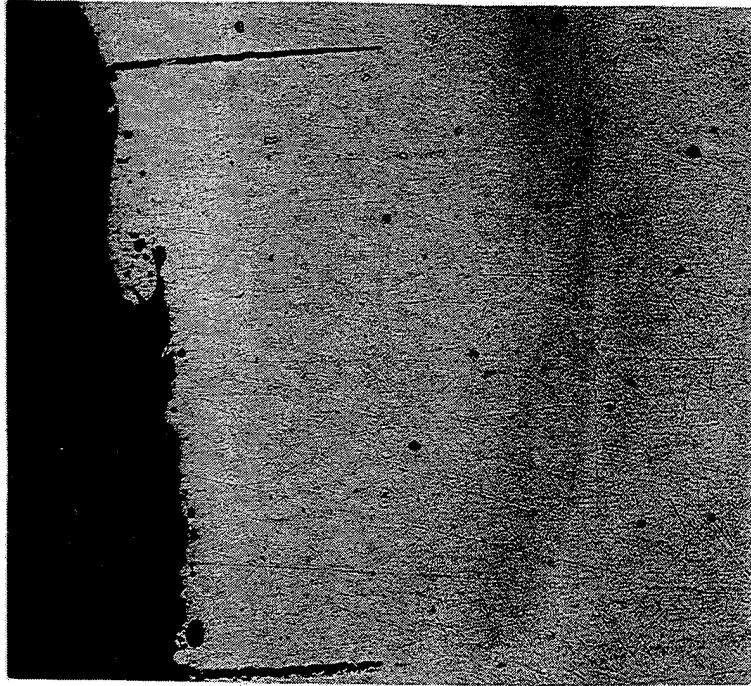
Figure 7 shows a crack that has formed at the root of the back fin. This crack is 350 μ long. To understand the mechanisms of the crack initiation and growth, the area was viewed at a higher magnification (fig. 8). As seen in figures 4 and 6, a section of this microstructure looks similar to an electron beam weld. Next to this microstructure,

where the cracks are located, is an area of over-aged aluminum. In this region, the heat was just enough to cause the magnesium and silicon in Al-7475 to diffuse out to the grain boundaries of the aluminum, substantially weakening the aluminum causing it to crack. These cracks were not formed from mechanical stress--they were formed from material changes brought on by the heat.

Figure 7
Crack formation at root(100X)

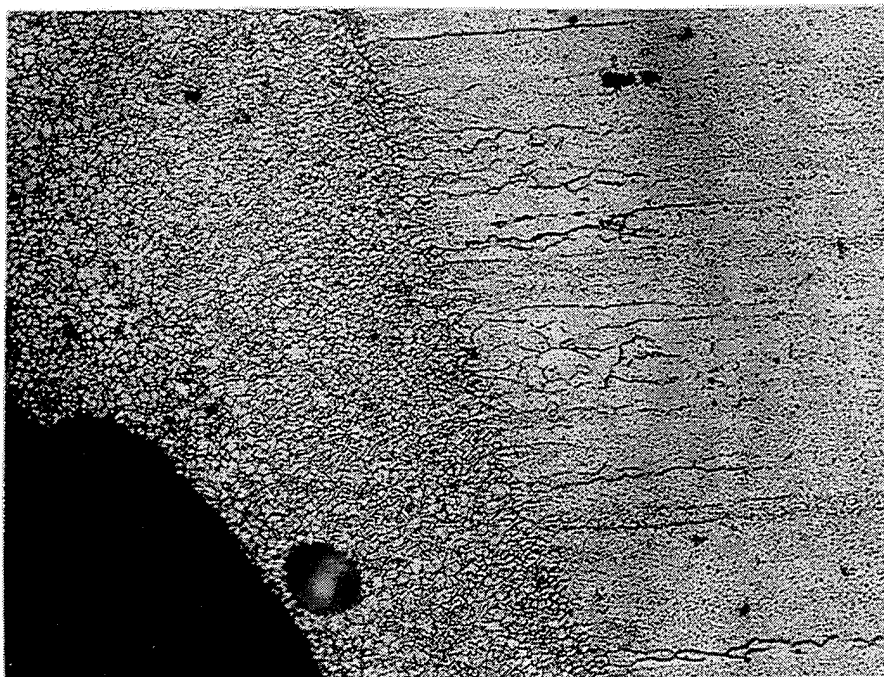
Figure 8
Microstructure of root (500X)

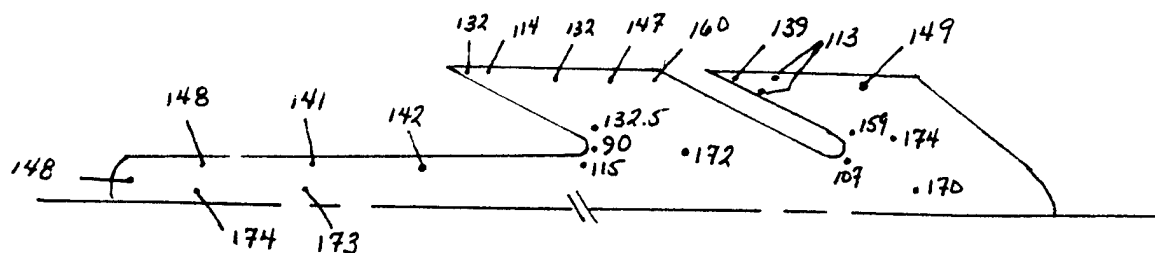
The hardness of Al-7475 is supposed to be 170-175 DPH. The hardness of the aluminum sabot is lower than this because of exposure to intense heat in the launcher. Figure 9 shows the hardness values from selected regions of the sabot. Only the central body of the armature did not experience hardness degradation. Softening occurred along the contact surfaces, at the roots of the contact surfaces, and along the tail or penetrator stabilizer area. The lowest hardnesses were seen at the tips of the contact surfaces and at the roots.

Figure 9
Hardness profile of sabot

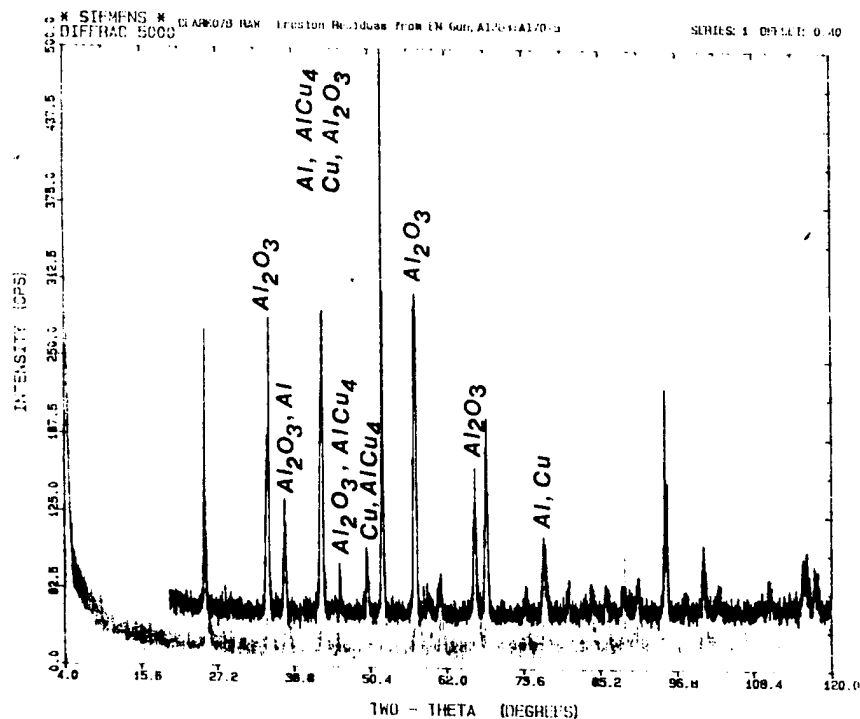
An x-ray diffraction spectrum was obtained from the debris (fig. 10). Some of the peaks were identified as aluminum, aluminum oxide (from the insulating sidewalls in the launcher), and copper; however, many of the peaks could not be identified. This points to non-stoichiometric alloying of these elements which is caused by incomplete melting and mixing.

Figure 10
X-ray diffraction pattern of black residue

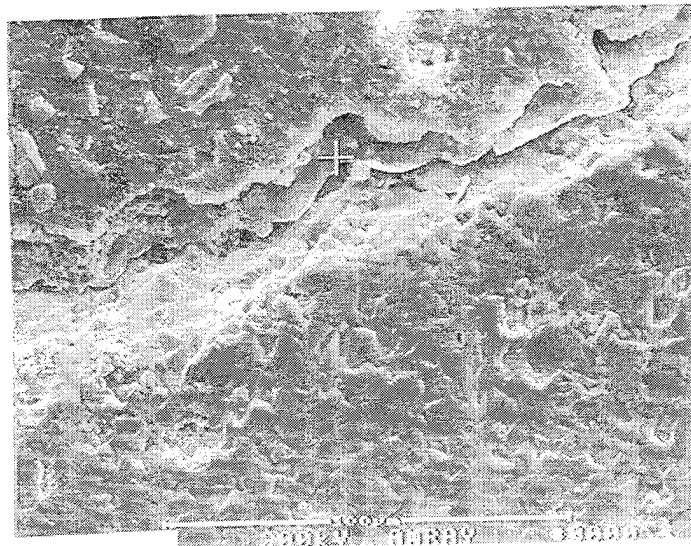
The microstructures of the larger chunks of debris from commissioning shots were analyzed. Figure 11 shows a 5 μ layer of black residue on a piece of the aluminum oxide insulating wall. Most of this black residue deposited on a piece of the aluminum oxide insulating wall in the form of submicron particles (fig. 12). However, there are also deposits of chromium-copper 30 μ wide that have landed on the wall in a molten

Figure 11
Layer of black residue on sidewalls (540X)

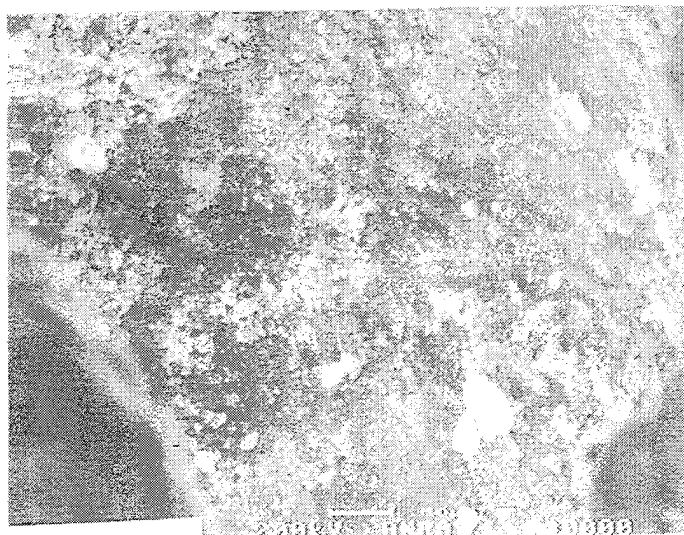
Figure 12
Black residue composed of submicron particles (825X)

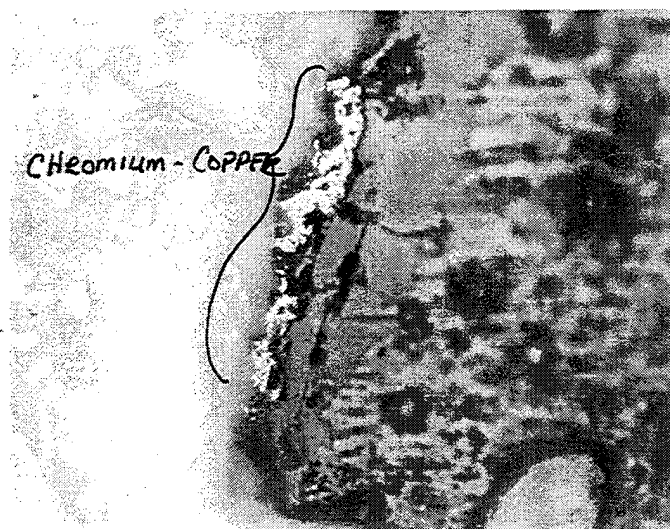
globular state (fig. 13). Due to melting and resolidification, the microstructure of this rail material has changed. Compare the original microstructure of the chromium-copper rails (fig. 14a) to the microstructure of the glob formed during commissioning (fig. 14b). In figure 14b, the chromium has come out of solution and migrated to the grain boundaries of the copper. It is unknown how hot the chromium-copper got or how fast it cooled in order to produce this microstructure. This change in the microstructure also points to changes in the physical properties of the chromium-copper such as hardness and conductivity. The original average hardness was 128 DPH, but the molten material has an average hardness of 70 DPH, which is very low. Since the conductivity of a material is usually inversely proportional to its hardness, it is likely that the conductivity has increased. No actual conductivity measurements could be made on the material since there was not enough to test.

Figure 13
Chromium-copper deposit on sidewalls (300X)

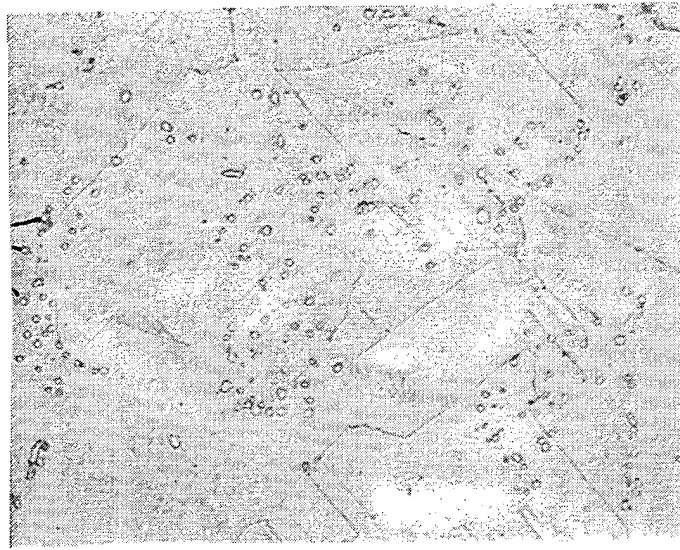
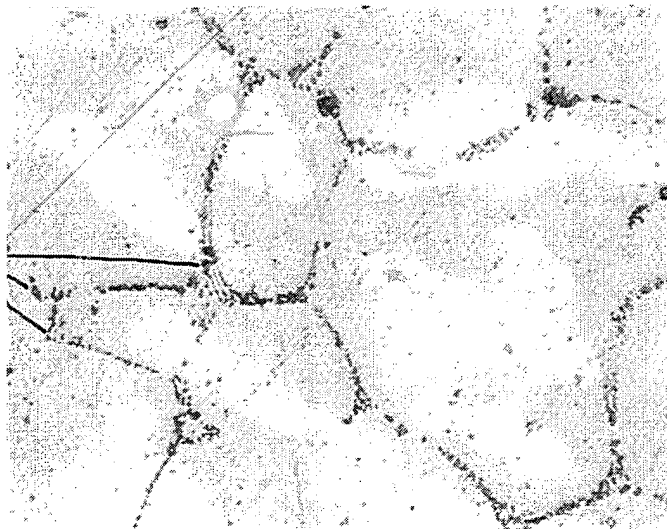
Figure 14
Microstructure of chromium-copper and chromium-copper deposit

5. The thickness of the black residue ranges from 5 to 30 μ . The residue deposited in the launcher in the form of submicron particles.
6. Globular pieces of chromium-copper found among the debris softened from 128 to 70 diamond pyramid hardness and had a different microstructure than the original rail material. Its conductivity has probably increased.

(a) Original microstructure of the chromium-cooper rails (750X)

(b) Microstructure of the chromium-copper deposit (750X)
